Manhole Inspection Summary

Manhole # S31QQ1005MH

Insp Date: **10/21/08 11:13 AM**

Location Address: **4 BLYTHEWOOD RD**

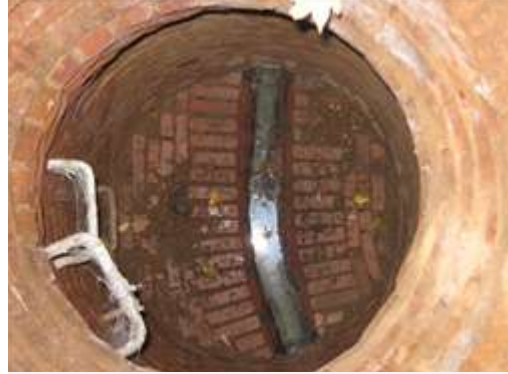
Top View

Corroded steps. Evidence of surcharge - Bench debris. Channel debris.

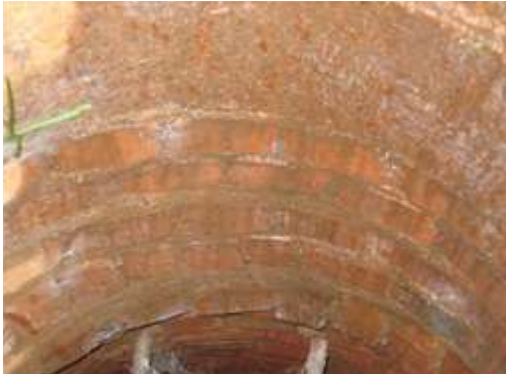
Defect

Adjustment and Barrel infiltration.

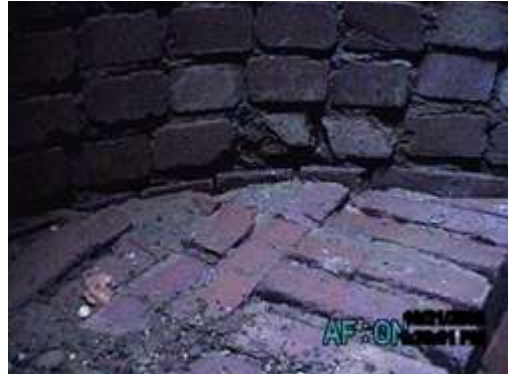
Defect

Barrel deterioration and infiltration. Bench deterioration.

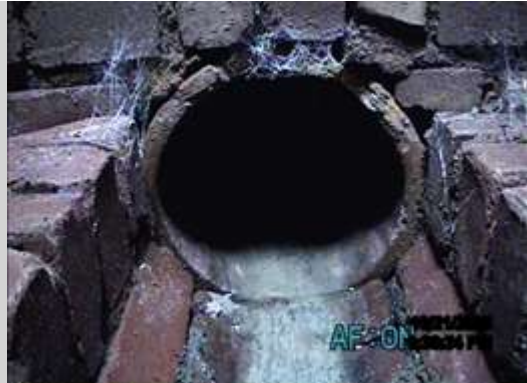
8 in. Circular Gravity Sewer Pipe Out @ 12 O'Clock

Channel deterioration.

Infiltration: **Evidence** Pipe Seal Cond: **Broken**
